**Flood Control Project Maintenance
Levee Inspections
LMA District Cover Sheet
Spring 2009 Levee Inspection Results**

San Joaquin County Flood Control District

Spring 2009 Levee Inspection Results

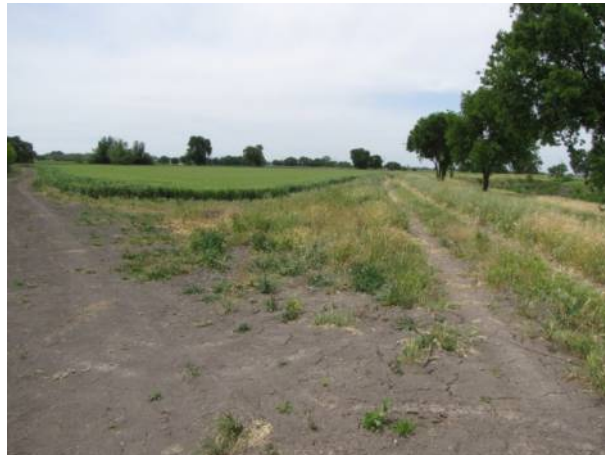
Levee Mile Report Line	4
Start Levee Mile	0.70
End Levee Mile	0.90
Location	Land Side
Category	Earthen Levee
Item	Vegetation
Control annual grass & weeds along crown and landside of levee from LM 0.70 to 0.90.

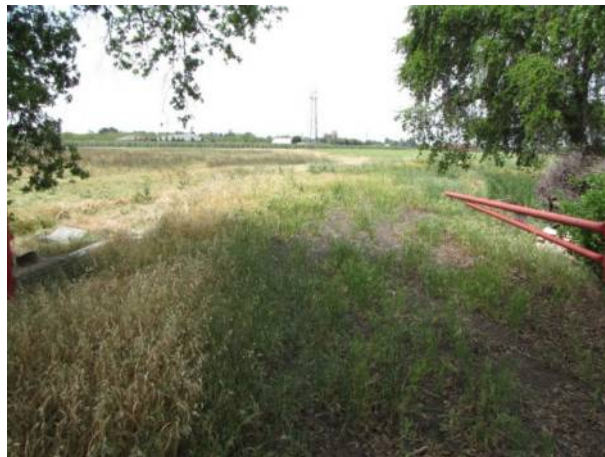
Levee Mile Report Line	5
Start Levee Mile	1.20
End Levee Mile	1.46
Location	Crown
Category	Earthen Levee
Item	Vegetation
Control annual grass & weeds along entire levee from LM 1.20 to 1.46.

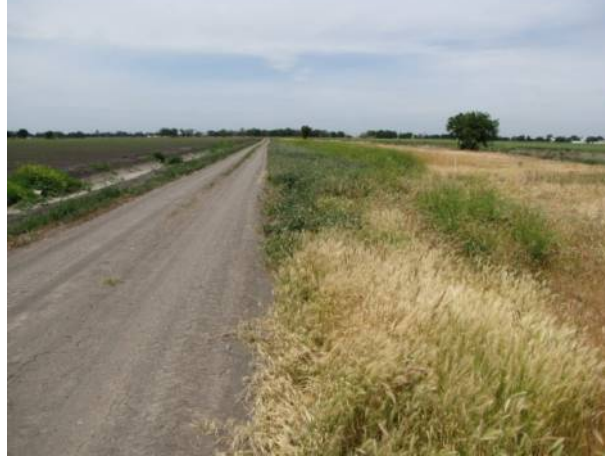
Levee Mile Report Line	8
Start Levee Mile	1.60
End Levee Mile	2.87
Location	Water Side
Category	Earthen Levee
Item	Vegetation

Control annual grass & weeds along water side of levee from LM 1.60 to LM 2.87.

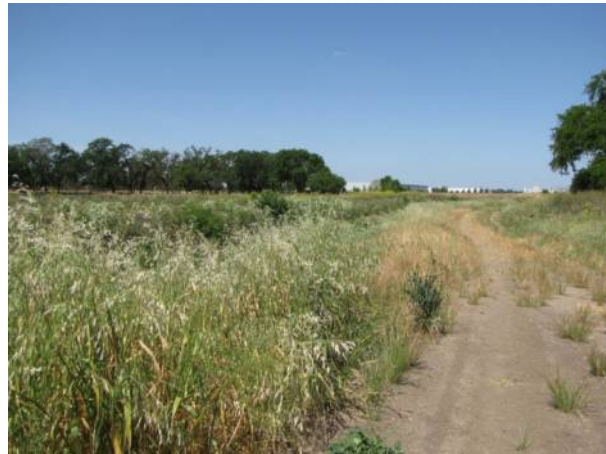
Levee Mile Report Line	6
Start Levee Mile	2.50
End Levee Mile	2.90
Location	Water Side
Category	Earthen Levee
Item	Vegetation
Remove/mow grass & vegetation along waterward levee slope.

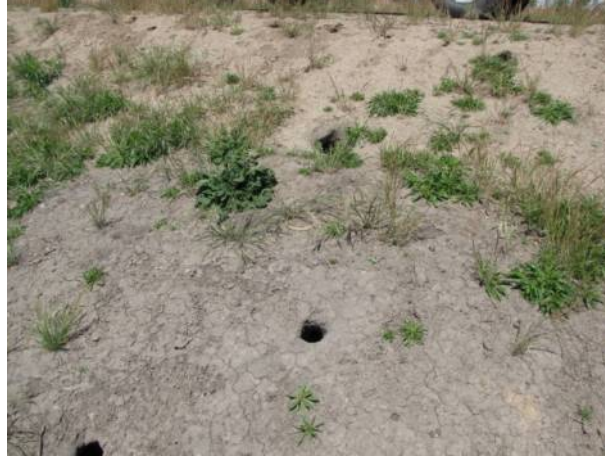
Levee Mile Report Line	9
Start Levee Mile	2.90
End Levee Mile	2.90
Location	Water Side
Category	Earthen Levee
Item	Animal Control

Example of rodent holes in this area. Backfill and compact all rodent holes.

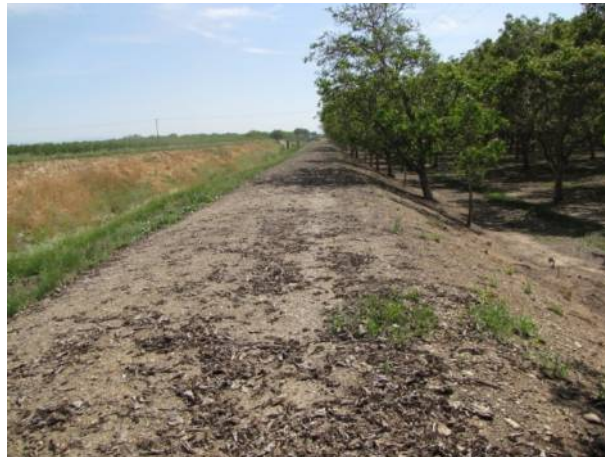
Levee Mile Report Line	2
Start Levee Mile	0.40
End Levee Mile	0.40
Location	Land Side
Category	Earthen Levee
Item	Vegetation
Example of good control of grass and weeds along crown and landside of levee at LM 0.40.

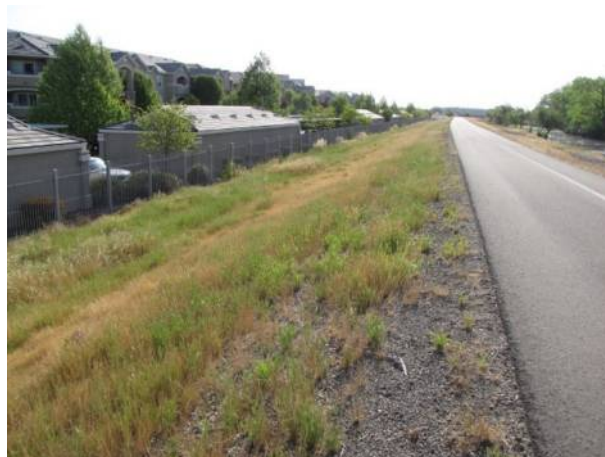
Levee Mile Report Line	2
Start Levee Mile	0.00
End Levee Mile	0.36
Location	Land Side
Category	Earthen Levee
Item	Vegetation
Remove/mow grass & vegetation along landward slope of levee.

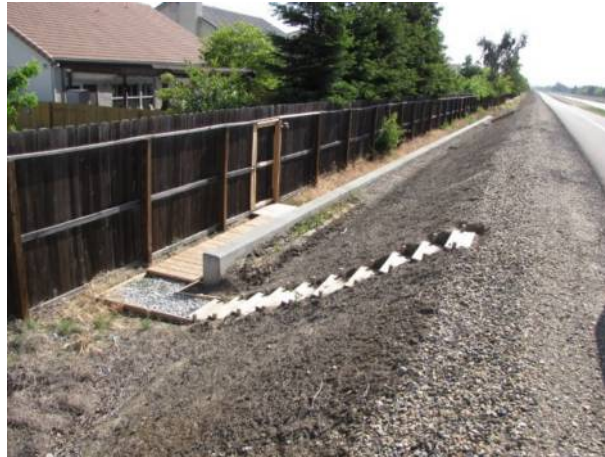
Levee Mile Report Line	4
Start Levee Mile	0.81
End Levee Mile	0.81
Location	Land Side
Category	Earthen Levee
Item	Encroachments
Stairs dug into levee slope. Remove the steps and recompact the levee slope.

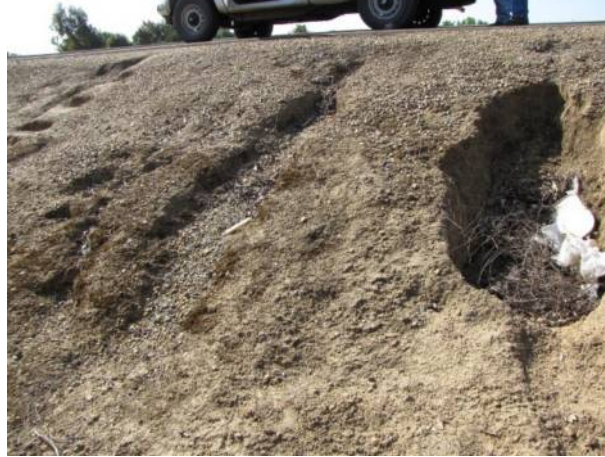
Levee Mile Report Line	6
Start Levee Mile	0.91
End Levee Mile	0.91
Location	Land Side
Category	Earthen Levee
Item	Erosion / Bank Caving
Repair erosion on landward slope of levee.

Additional view of erosion on landward slope of levee.

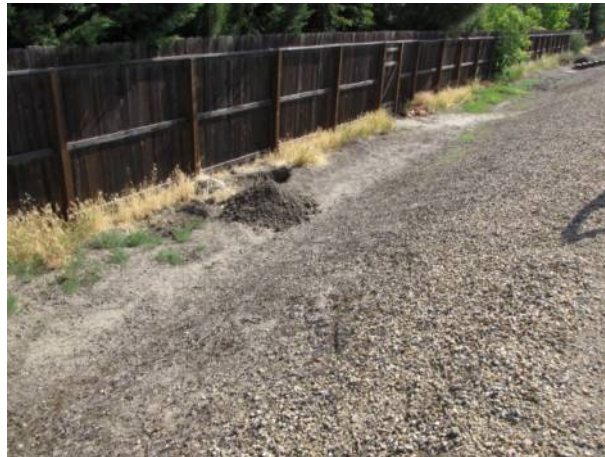
Levee Mile Report Line	7
Start Levee Mile	1.03
End Levee Mile	1.03
Location	Land Side
Category	Earthen Levee
Item	Slope Stability

Backfill and compact hole dug along landward toe of levee.

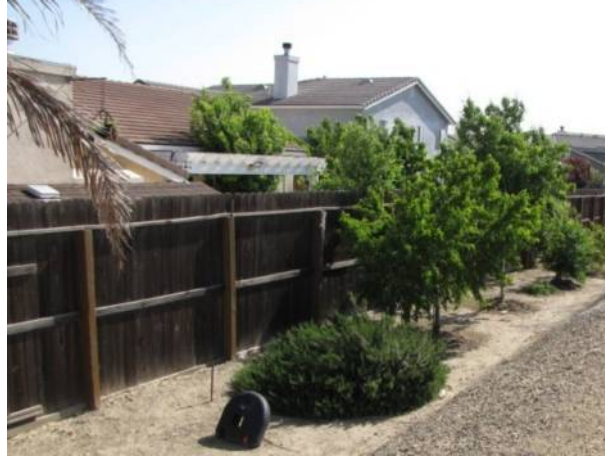
Levee Mile Report Line	9
Start Levee Mile	1.18
End Levee Mile	1.18
Location	Land Side
Category	Earthen Levee
Item	Encroachments
Landscaping within 10' of landward toe of levee.

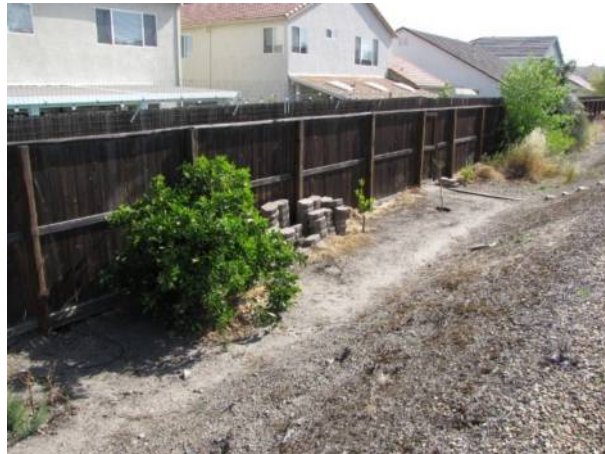
Levee Mile Report Line	10
Start Levee Mile	1.39
End Levee Mile	1.39
Location	Land Side
Category	Earthen Levee
Item	Encroachments
Landscaping within 10' of toe of levee.

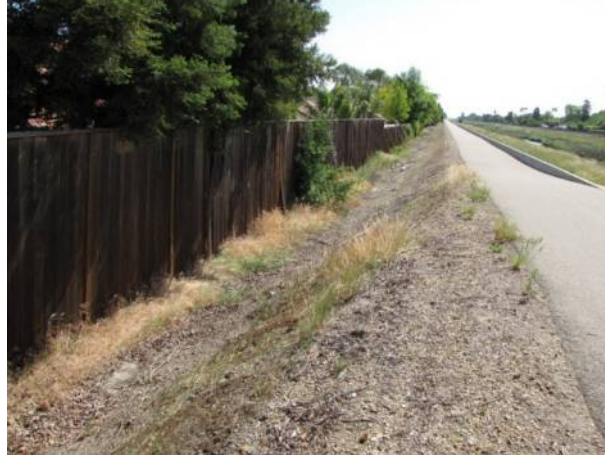
Levee Mile Report Line	13
Start Levee Mile	1.66
End Levee Mile	1.98
Location	Land Side
Category	Earthen Levee
Item	Vegetation
Remove/mow grass & vegetation within 10' of landward levee toe.

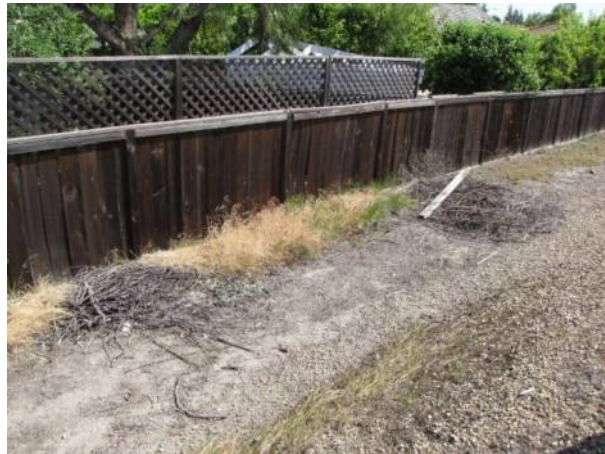
Levee Mile Report Line	14
Start Levee Mile	1.75
End Levee Mile	1.75
Location	Land Side
Category	Earthen Levee
Item	Encroachments
Remove prunings within 10' of landward toe of levee.

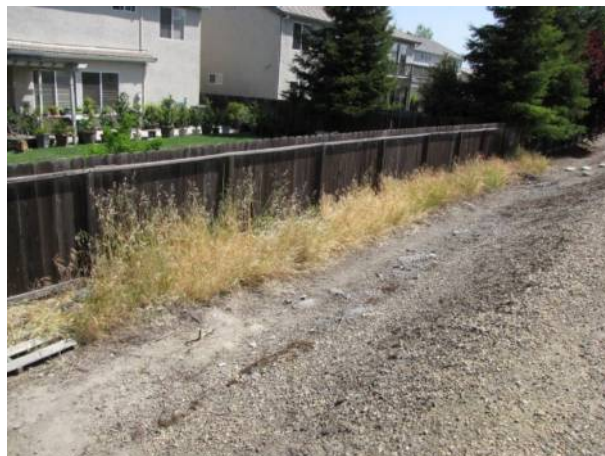
Levee Mile Report Line	15
Start Levee Mile	2.10
End Levee Mile	2.10
Location	Land Side
Category	Earthen Levee
Item	Vegetation
Remove/mow grass & vegetation within 10' of landward toe of levee.

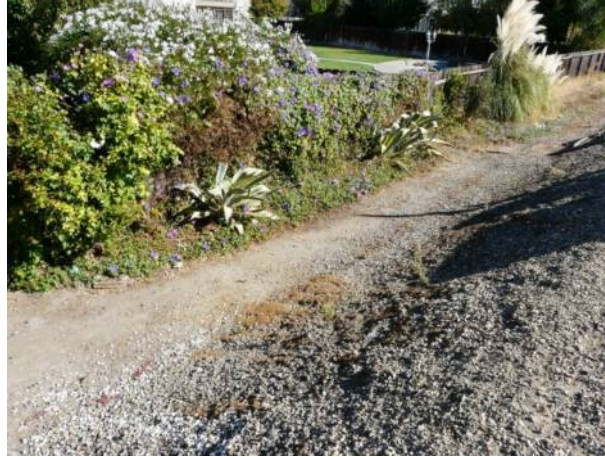
Levee Mile Report Line	17
Start Levee Mile	2.28
End Levee Mile	2.28
Location	Land Side
Category	Earthen Levee
Item	Encroachments

Landscaping located within 10' of landside toe of levee at LM 2.28.

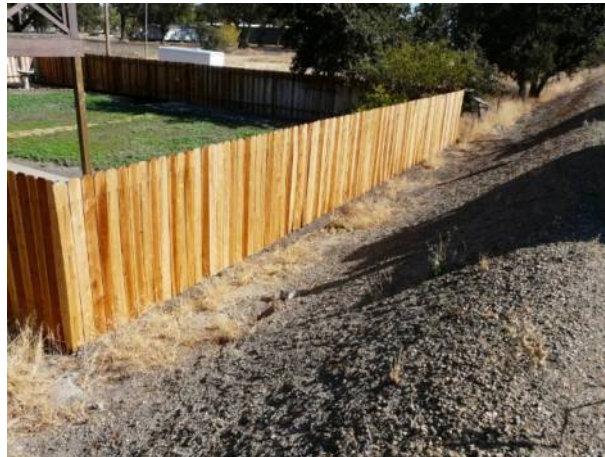
Levee Mile Report Line	20
Start Levee Mile	2.66
End Levee Mile	2.67
Location	Land Side
Category	Earthen Levee
Item	Encroachments

Newer fence built within landside toe of levee at from LM 2.66 to LM 2.67.

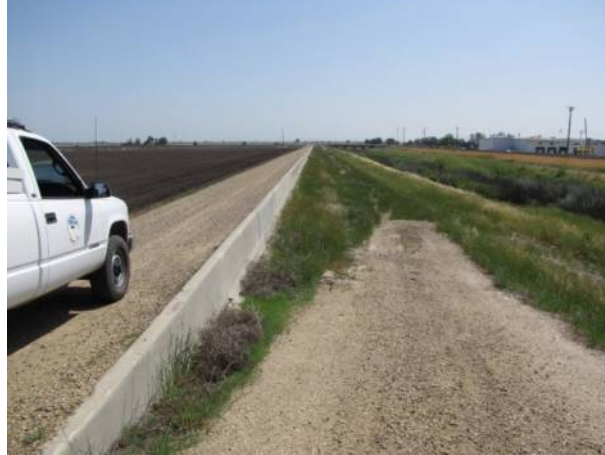
Levee Mile Report Line	22
Start Levee Mile	3.14
End Levee Mile	3.38
Location	Water Side
Category	Earthen Levee
Item	Vegetation
Remove/mow grass & vegetation along top 20' along waterward side of levee.

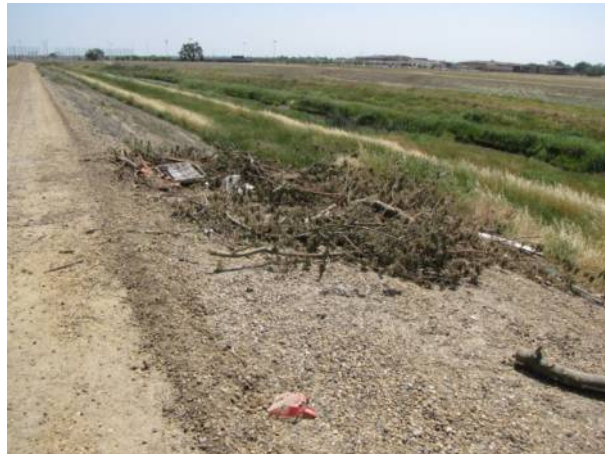
Levee Mile Report Line	24
Start Levee Mile	4.10
End Levee Mile	4.10
Location	Water Side
Category	Earthen Levee
Item	Encroachments
Remove prunings & debris from waterward slope of levee.

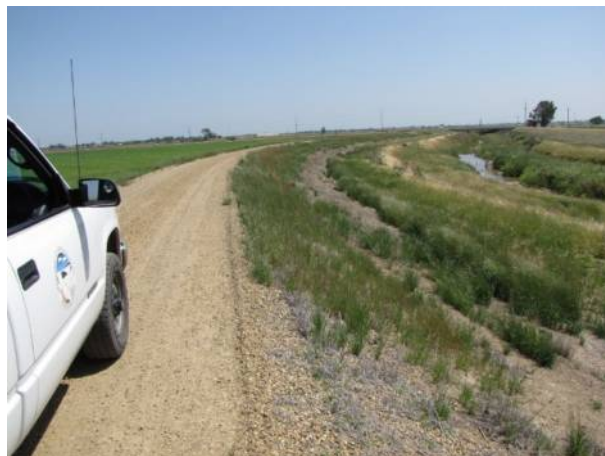
Levee Mile Report Line	25
Start Levee Mile	4.37
End Levee Mile	4.59
Location	Water Side
Category	Earthen Levee
Item	Vegetation
Remove/mow grass & vegetation along top 20' along waterward side of levee.

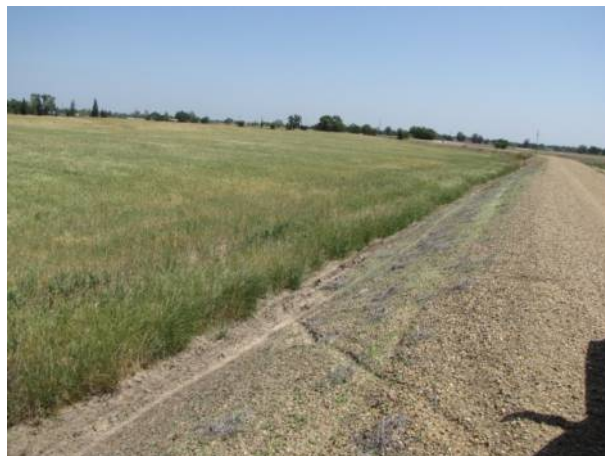
Levee Mile Report Line	30
Start Levee Mile	6.24
End Levee Mile	6.80
Location	Land Side
Category	Earthen Levee
Item	Vegetation
Remove/mow vegetation within 10' of landward toe of levee.

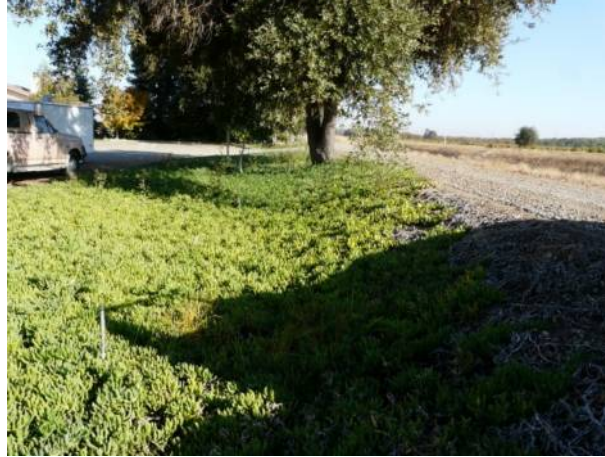
Levee Mile Report Line	57
Start Levee Mile	14.09
End Levee Mile	14.13
Location	Water Side
Category	Earthen Levee
Item	Encroachments

Landscaping on landside of levee from LM 14.09 to LM 14.13.

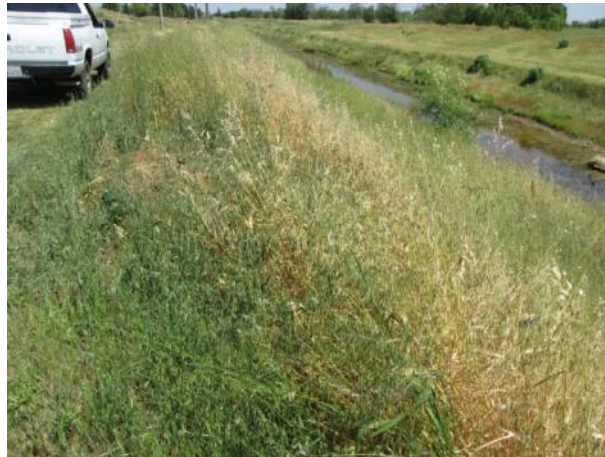
Levee Mile Report Line	59
Start Levee Mile	15.17
End Levee Mile	15.64
Location	Water Side
Category	Earthen Levee
Item	Vegetation

Remove/mow grass & vegetation along top 20' along waterward side of levee.

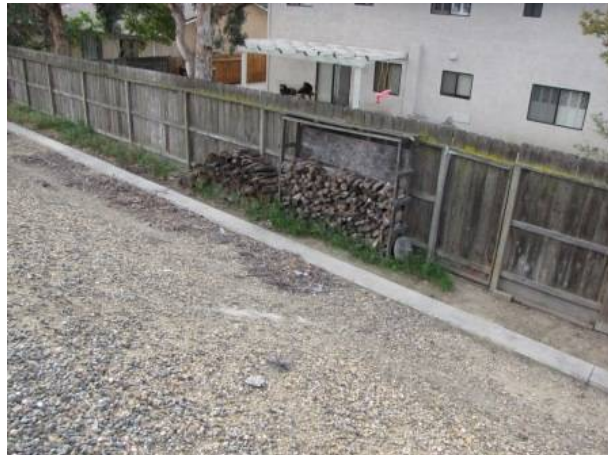
Levee Mile Report Line	2
Start Levee Mile	1.18
End Levee Mile	1.18
Location	Land Side
Category	Earthen Levee
Item	Encroachments
Remove firewood from within 10' of landward toe of levee.

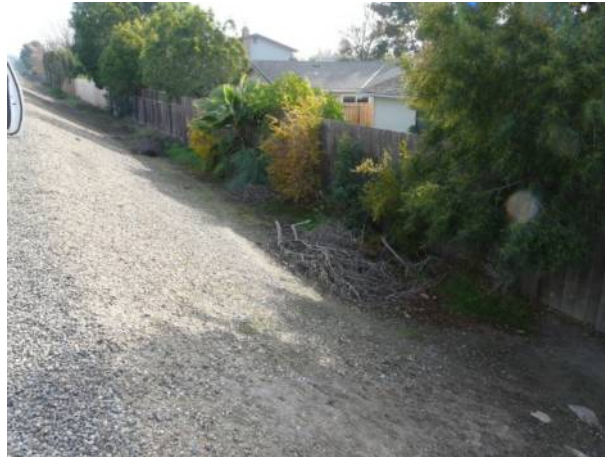
Levee Mile Report Line	7
Start Levee Mile	1.48
End Levee Mile	1.48
Location	Land Side
Category	Earthen Levee
Item	Encroachments
Landscaping along toe of landside of levee at LM 1.48

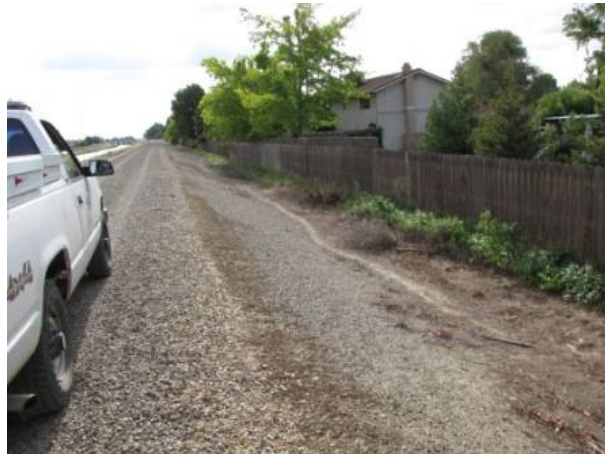
Levee Mile Report Line	8
Start Levee Mile	1.54
End Levee Mile	1.78
Location	Land Side
Category	Earthen Levee
Item	Vegetation
Remove grass & vegetation from within 10' of landward toe of levee.

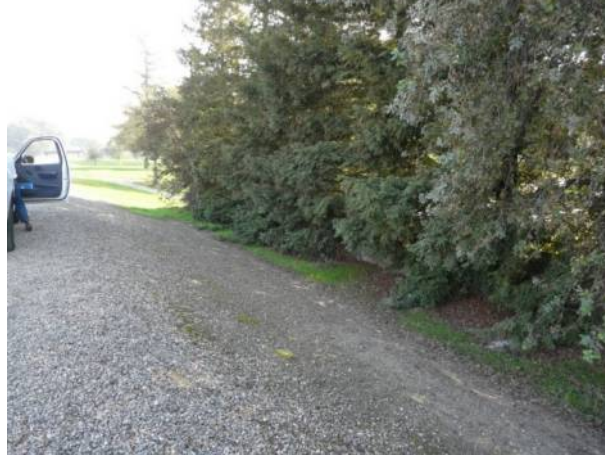
Levee Mile Report Line	11
Start Levee Mile	1.77
End Levee Mile	1.77
Location	Land Side
Category	Earthen Levee
Item	Encroachments
Landscaping along landside toe of levee at LM 1.77

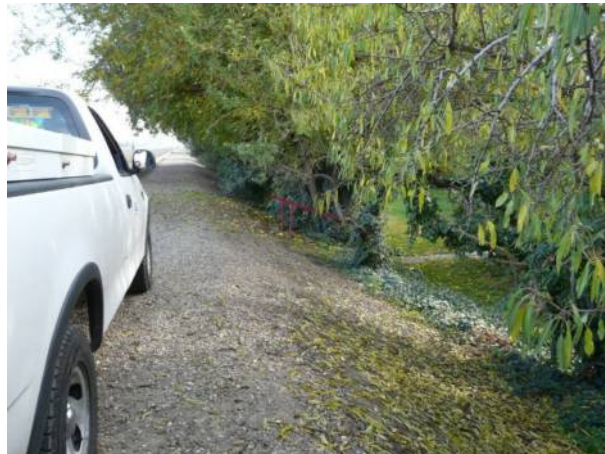
Levee Mile Report Line	12
Start Levee Mile	2.06
End Levee Mile	2.17
Location	Land Side
Category	Earthen Levee
Item	Encroachments
Landscaping along landside of levee from LM 2.06 to LM 2.17

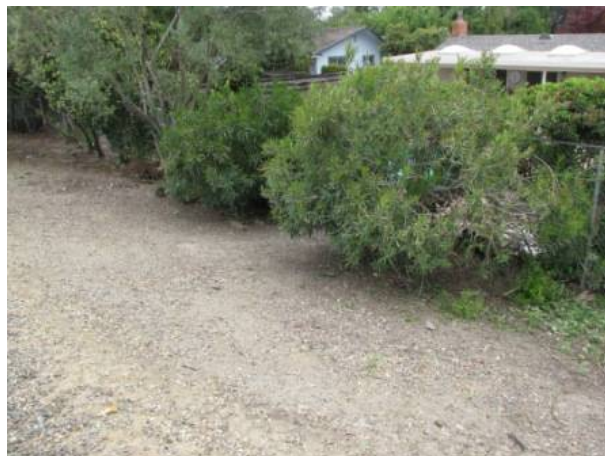
Levee Mile Report Line	17
Start Levee Mile	2.32
End Levee Mile	2.32
Location	Land Side
Category	Earthen Levee
Item	Encroachments
Landscaping along landward slope of levee blocking visibility & access.

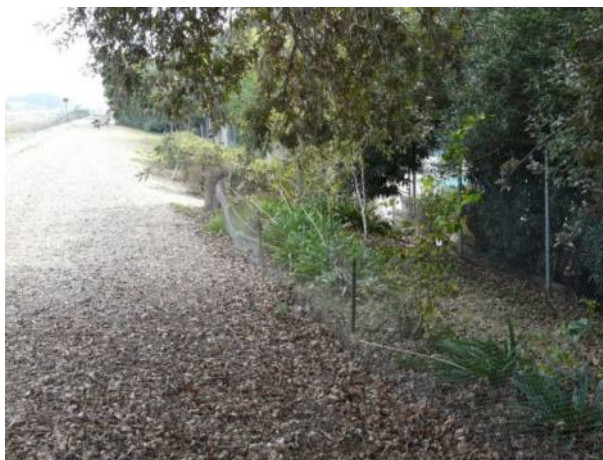
Levee Mile Report Line	19
Start Levee Mile	2.33
End Levee Mile	2.34
Location	Land Side
Category	Earthen Levee
Item	Encroachments
Garden located on landside slope of levee from LM 2.32 to LM 2.35

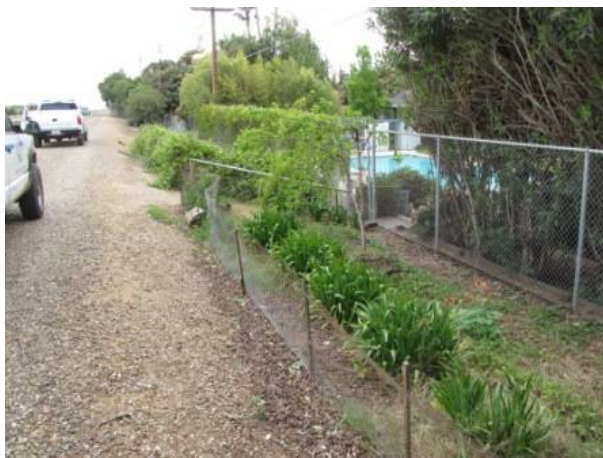
Levee Mile Report Line	20
Start Levee Mile	2.36
End Levee Mile	2.36
Location	Land Side
Category	Earthen Levee
Item	Encroachments
Landscaping & garden along landward slope of levee.

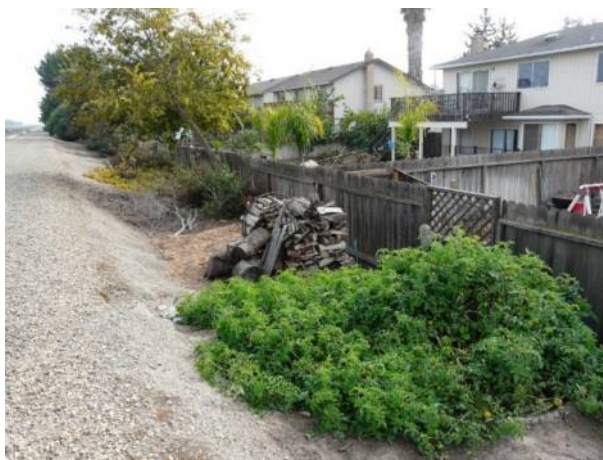
Levee Mile Report Line	24
Start Levee Mile	2.47
End Levee Mile	2.47
Location	Land Side
Category	Earthen Levee
Item	Encroachments
Remove firewood from landside of levee slope at LM 2.47

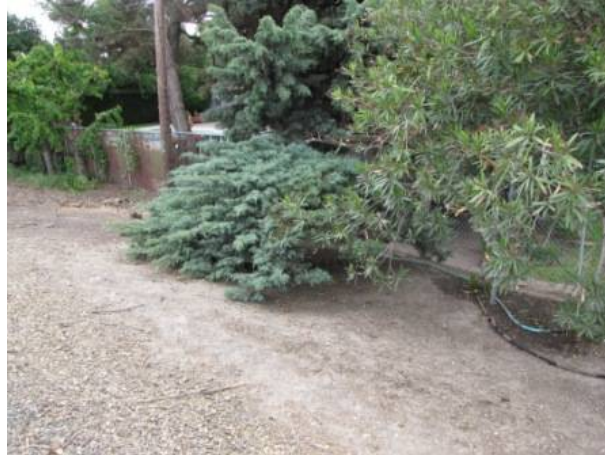
Levee Mile Report Line	25
Start Levee Mile	2.47
End Levee Mile	2.47
Location	Land Side
Category	Earthen Levee
Item	Encroachments
Landscaping along landward slope of levee blocking visibility and access.

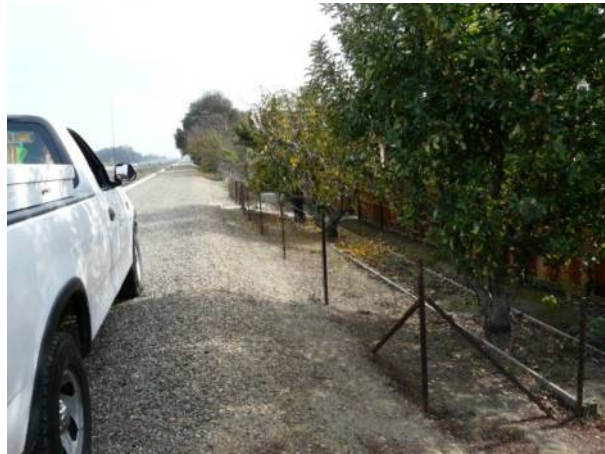
Levee Mile Report Line	28
Start Levee Mile	2.58
End Levee Mile	2.61
Location	Land Side
Category	Earthen Levee
Item	Encroachments
Fence located to sholder of landside of levee from LM 2.58 to LM 5.61

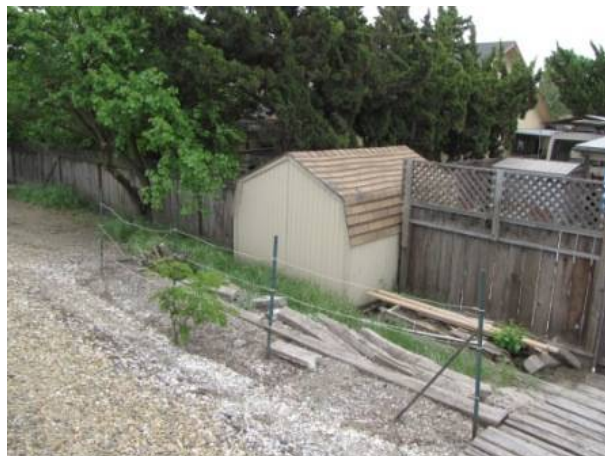
Levee Mile Report Line	29
Start Levee Mile	2.61
End Levee Mile	2.61
Location	Land Side
Category	Earthen Levee
Item	Encroachments
Landscaping and shed placed on landward levee slope and within 10' of the toe.

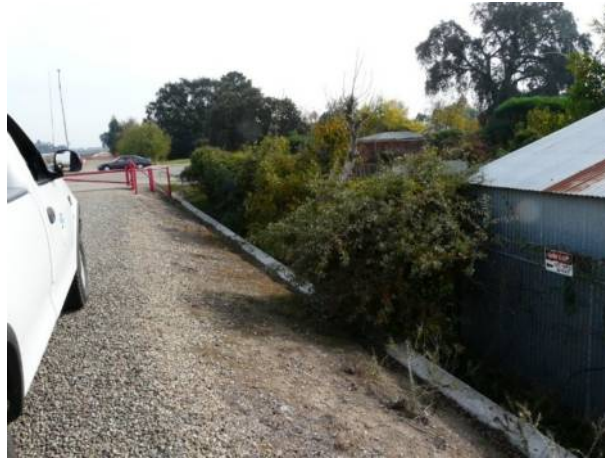
Levee Mile Report Line	34
Start Levee Mile	2.87
End Levee Mile	2.89
Location	Land Side
Category	Earthen Levee
Item	Encroachments

Landscaping along landside toe of levee from LM 2.87 to LM 2.89

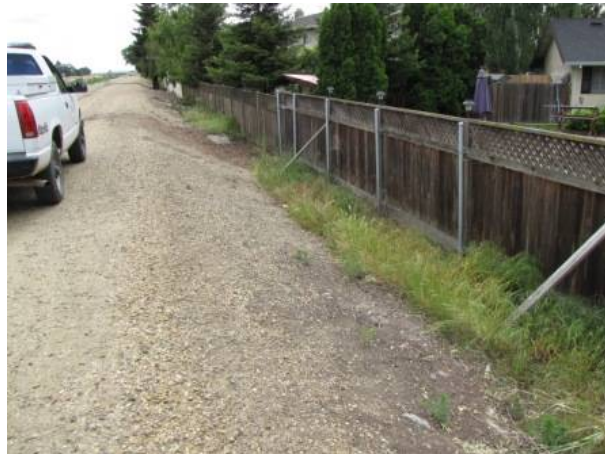
Levee Mile Report Line	36
Start Levee Mile	2.96
End Levee Mile	2.96
Location	Land Side
Category	Earthen Levee
Item	Vegetation

Remove/mow grass & vegetation along landward slope of levee & within 10' of the toe.

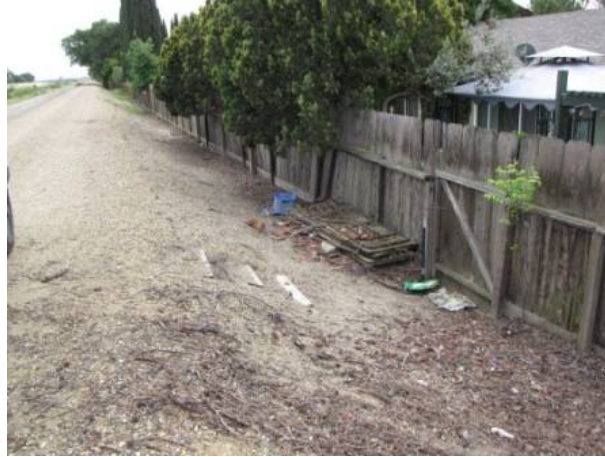
Levee Mile Report Line	39
Start Levee Mile	3.01
End Levee Mile	3.01
Location	Land Side
Category	Earthen Levee
Item	Encroachments
Remove debris within 10' of the landward toe of the levee.

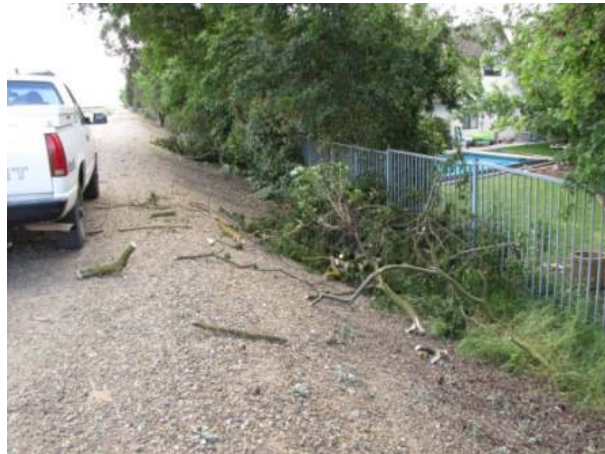
Levee Mile Report Line	41
Start Levee Mile	3.16
End Levee Mile	3.16
Location	Land Side
Category	Earthen Levee
Item	Encroachments
Remove prunings along landward levee slope and within 10' of the toe.

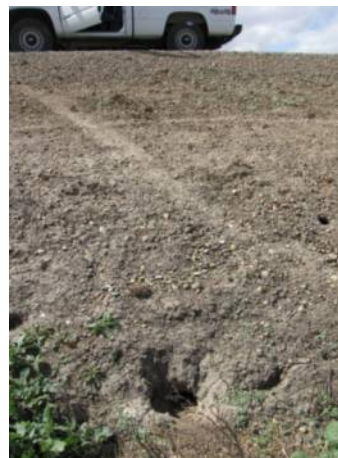
Levee Mile Report Line	46
Start Levee Mile	4.09
End Levee Mile	4.09
Location	Water Side
Category	Earthen Levee
Item	Animal Control
Example rodent hole along waterward slope of levee. Exterminate rodent and backfill and compact rodent holes.

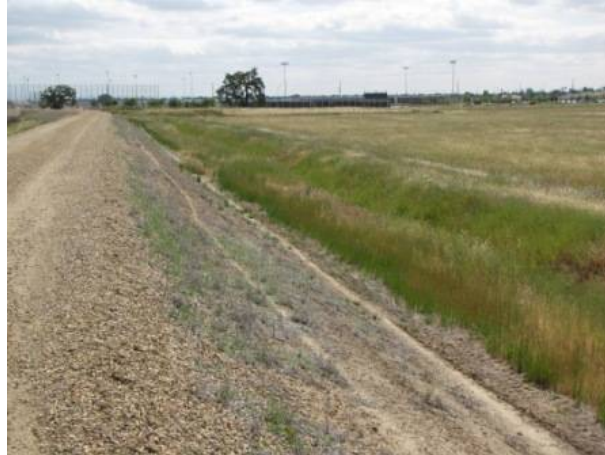
Levee Mile Report Line	47
Start Levee Mile	4.47
End Levee Mile	4.96
Location	Land Side
Category	Earthen Levee
Item	Vegetation
Remove/mow grass & vegetation along landward slope of levee & within 10' of the toe.

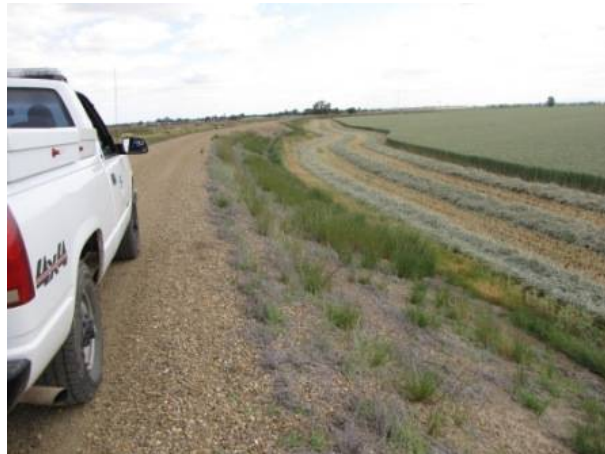
Levee Mile Report Line	49
Start Levee Mile	5.26
End Levee Mile	5.64
Location	Land Side
Category	Earthen Levee
Item	Vegetation
Remove/mow grass & vegetation along landward slope of levee & within 10' of the toe.

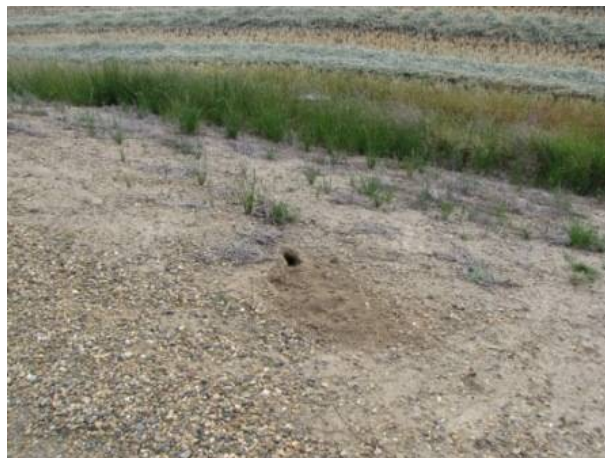
Levee Mile Report Line	50
Start Levee Mile	5.32
End Levee Mile	5.32
Location	Land Side
Category	Earthen Levee
Item	Animal Control
Example of rodent hole along landward slope of the levee. Exterminate the rodent and backfill and compact the rodent holes.

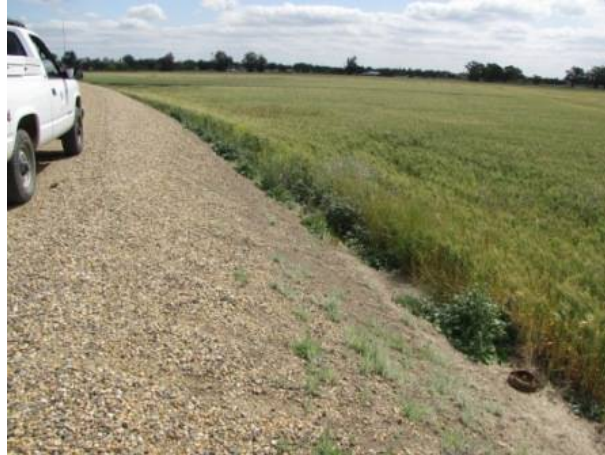
Levee Mile Report Line	51
Start Levee Mile	6.94
End Levee Mile	7.18
Location	Land Side
Category	Earthen Levee
Item	Encroachments
Crops planted within 10' of landward toe of the levee.

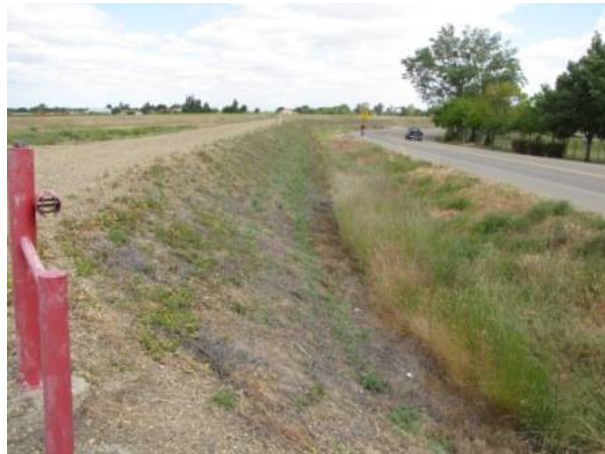
Levee Mile Report Line	52
Start Levee Mile	7.28
End Levee Mile	7.45
Location	Land Side
Category	Earthen Levee
Item	Vegetation
Remove/mow grass & vegetation along landward slope of levee & within 10' of the toe.

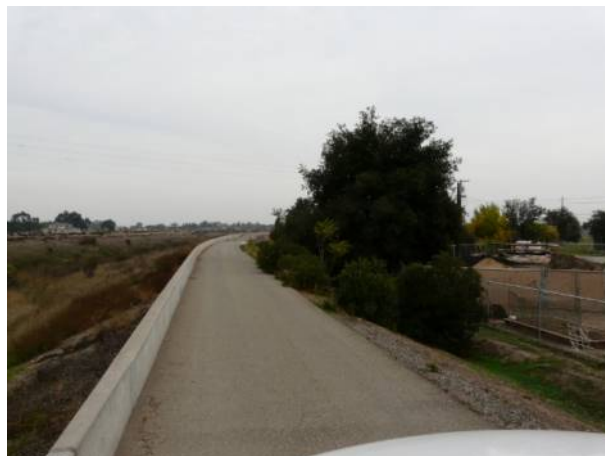
Levee Mile Report Line	54
Start Levee Mile	7.57
End Levee Mile	7.62
Location	Land Side
Category	Earthen Levee
Item	Encroachments
Landscaping along landside slope of levee at from LM 7.57 to 7.62

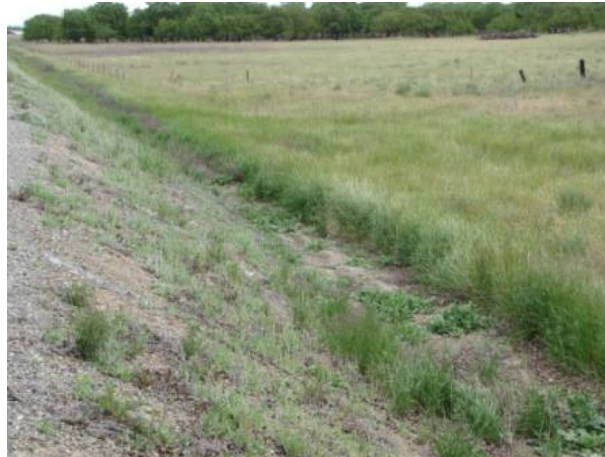
Levee Mile Report Line	55
Start Levee Mile	8.18
End Levee Mile	8.33
Location	Land Side
Category	Earthen Levee
Item	Vegetation
Remove/mow grass & vegetation along landward slope of levee & within 10' of the toe.

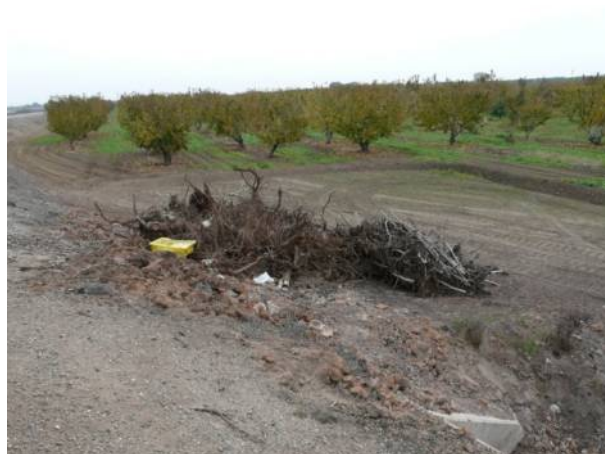
Levee Mile Report Line	56
Start Levee Mile	9.52
End Levee Mile	9.52
Location	Land Side
Category	Earthen Levee
Item	Encroachments
Remove prunings from landside of levee at LM 9.52

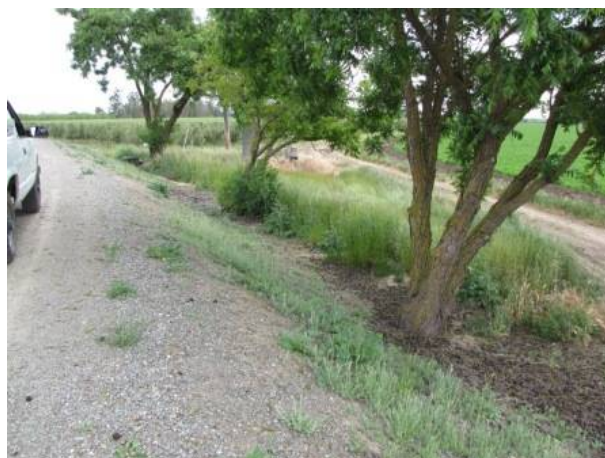
Levee Mile Report Line	57
Start Levee Mile	9.99
End Levee Mile	9.99
Location	Land Side
Category	Earthen Levee
Item	Vegetation
Remove/mow grass & vegetation along landward slope of levee & within 10' of the toe.

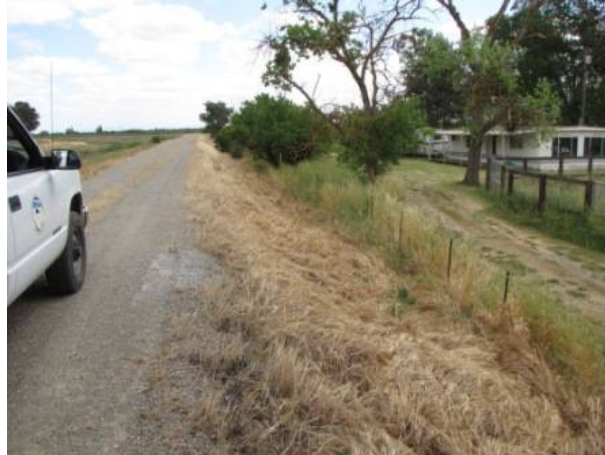
Levee Mile Report Line	58
Start Levee Mile	10.48
End Levee Mile	10.57
Location	Land Side
Category	Earthen Levee
Item	Vegetation
Remove/mow grass & vegetation along landward slope of levee & within 10' of the toe.

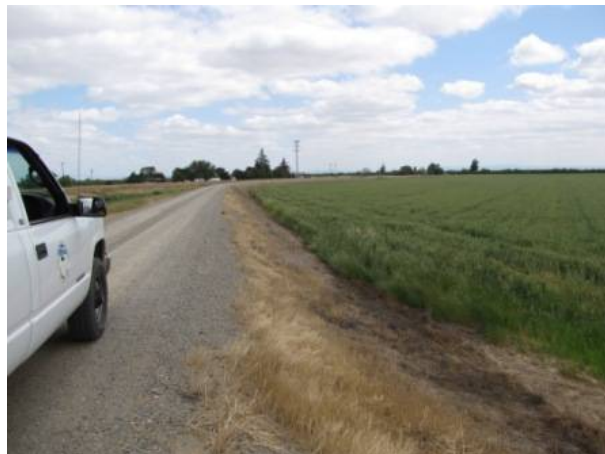
Levee Mile Report Line	59
Start Levee Mile	10.98
End Levee Mile	11.29
Location	Land Side
Category	Earthen Levee
Item	Encroachments
Crops planted within 10' of landward toe of levee.

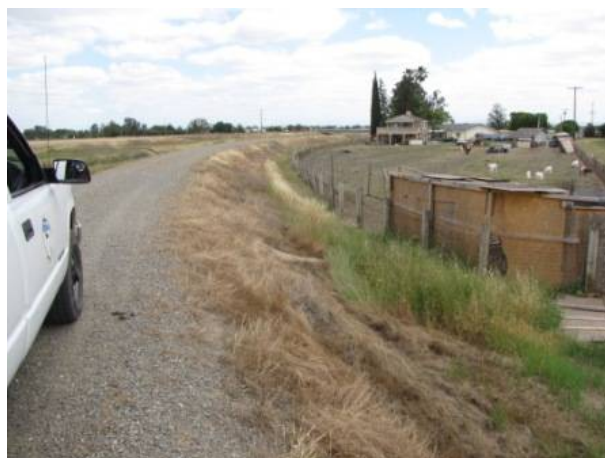
Levee Mile Report Line	60
Start Levee Mile	12.60
End Levee Mile	12.67
Location	Land Side
Category	Earthen Levee
Item	Vegetation
Remove/mow grass & vegetation along landward slope of levee & within 10' of the toe.

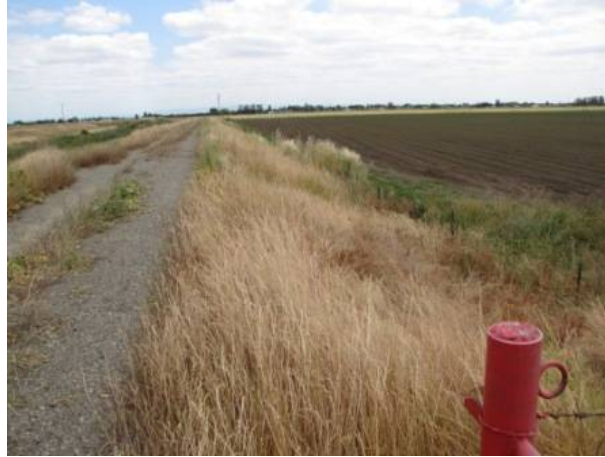
Levee Mile Report Line	62
Start Levee Mile	12.77
End Levee Mile	13.05
Location	Land Side
Category	Earthen Levee
Item	Vegetation
Remove/mow grass & vegetation along landward slope of levee & within 10' of the toe.

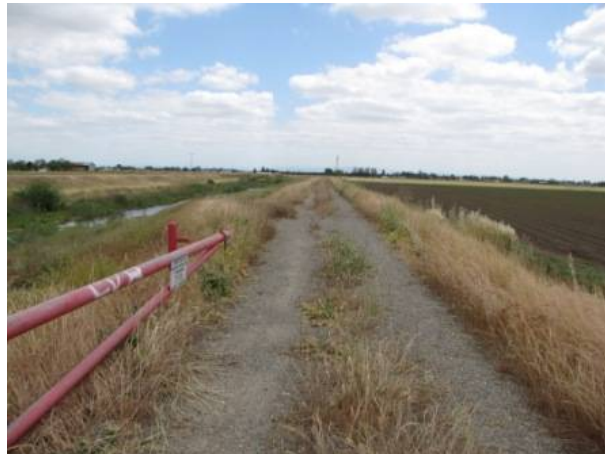
Levee Mile Report Line	63
Start Levee Mile	12.77
End Levee Mile	13.05
Location	Crown
Category	Earthen Levee
Item	Vegetation
Remove/mow vegetation along crown of levee.

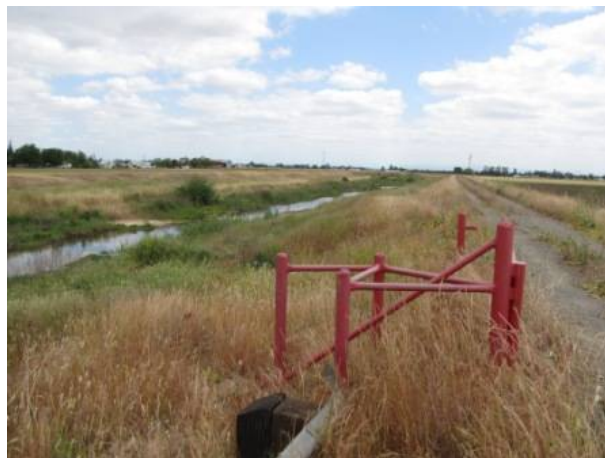
Levee Mile Report Line	64
Start Levee Mile	12.77
End Levee Mile	13.05
Location	Water Side
Category	Earthen Levee
Item	Vegetation
Remove/mow grass & vegetation along top 20' of waterward slope of levee.

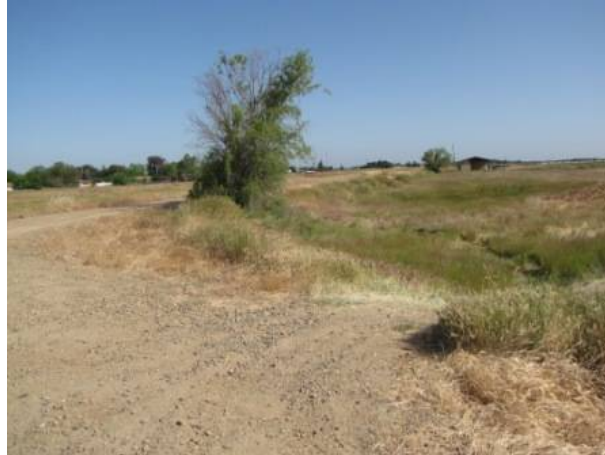
Levee Mile Report Line	65
Start Levee Mile	13.05
End Levee Mile	13.48
Location	Land Side
Category	Earthen Levee
Item	Vegetation
Remove/mow grass & vegetation along landward slope of levee & within 10' of the toe.

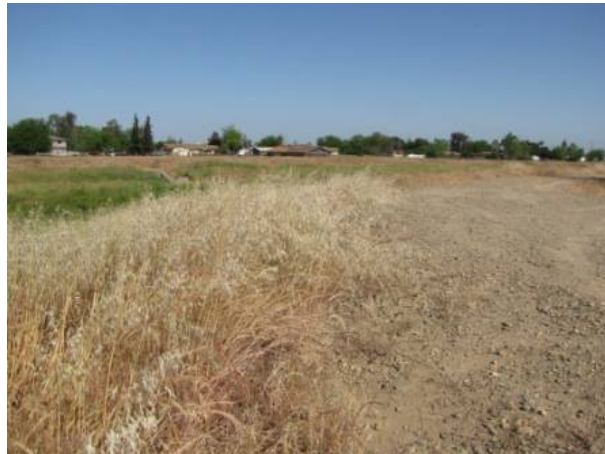
Levee Mile Report Line	66
Start Levee Mile	13.05
End Levee Mile	15.74
Location	Water Side
Category	Earthen Levee
Item	Vegetation
Remove/mow grass & vegetation along top 20' of waterward levee slope.

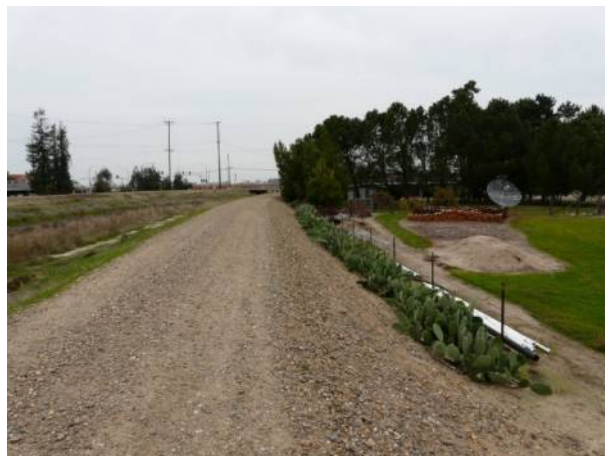
Levee Mile Report Line	67
Start Levee Mile	13.51
End Levee Mile	13.59
Location	Land Side
Category	Earthen Levee
Item	Encroachments
Landscaping along landside of levee from LM 13.51 to LM 13.59. Trim trees along landside of levee slope to allow for visibility from LM 13.54 to 13.59.

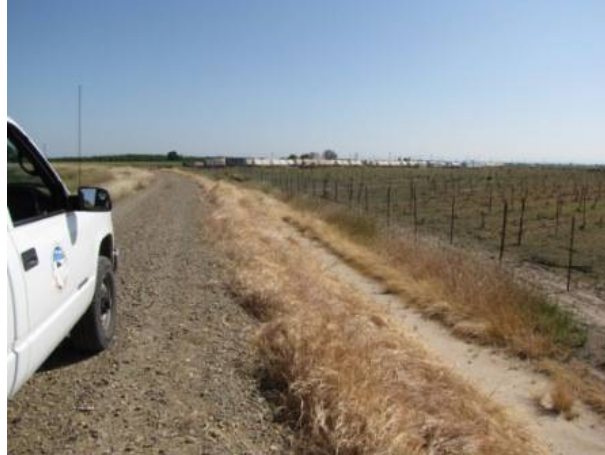
Levee Mile Report Line	69
Start Levee Mile	14.11
End Levee Mile	15.30
Location	Land Side
Category	Earthen Levee
Item	Vegetation
Remove/mow grass & vegetation along landward slope of levee & within 10' of the toe.

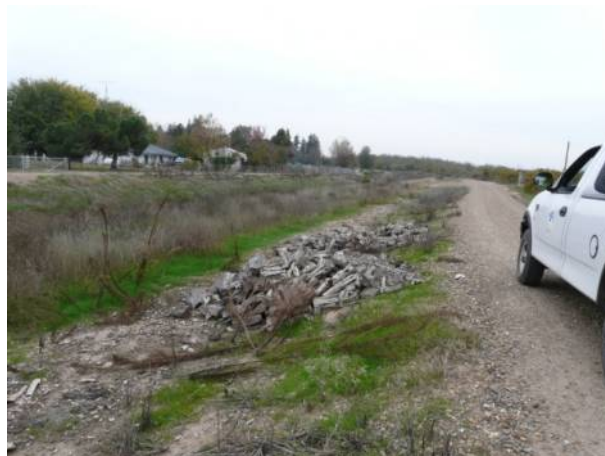
Levee Mile Report Line	71
Start Levee Mile	14.90
End Levee Mile	14.90
Location	Water Side
Category	Earthen Levee
Item	Encroachments
Remove prunings from waterside of levee at LM 14.90

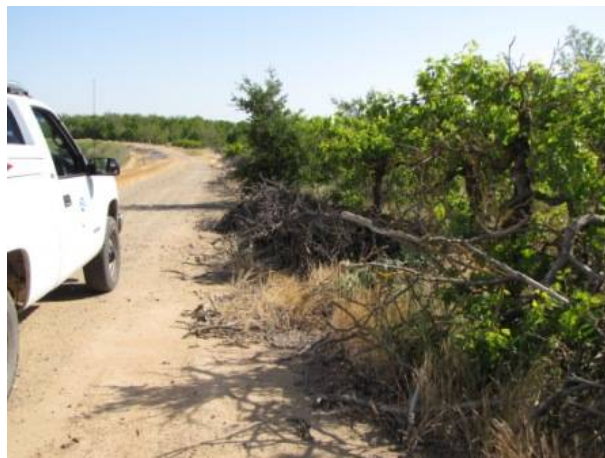
Levee Mile Report Line	72
Start Levee Mile	14.96
End Levee Mile	15.00
Location	Land Side
Category	Earthen Levee
Item	Encroachments
Remove prunings from landward sholder of levee/access road.

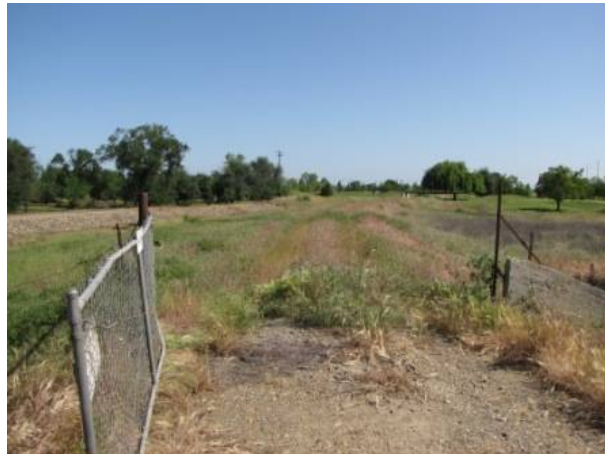
Levee Mile Report Line	77
Start Levee Mile	15.23
End Levee Mile	15.30
Location	Crown
Category	Earthen Levee
Item	Vegetation

Remove/mow grass along crown of levee.

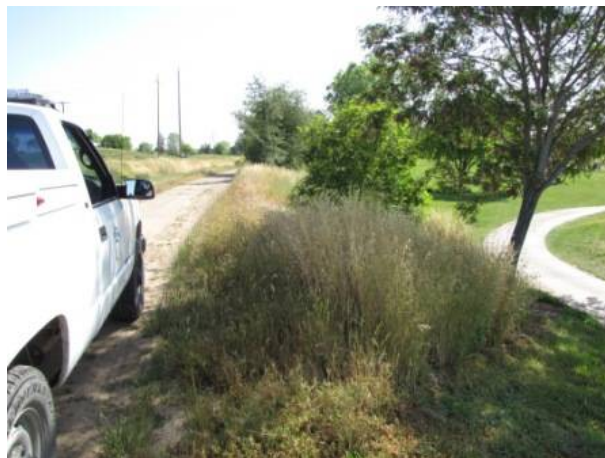
Levee Mile Report Line	78
Start Levee Mile	15.40
End Levee Mile	15.72
Location	Land Side
Category	Earthen Levee
Item	Vegetation

Remove/mow grass & vegetation along landward slope of levee & within 10' of the toe.

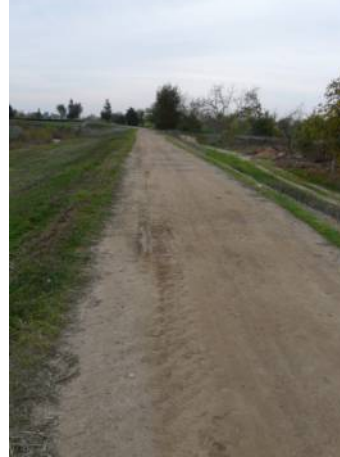
Levee Mile Report Line	79
Start Levee Mile	15.64
End Levee Mile	15.74
Location	Crown
Category	Earthen Levee
Item	Crown Surface / Depressions / Rutting
Regrade crown of levee to provide proper drainage and prevent ponding from LM 15.64 to LM 15.74

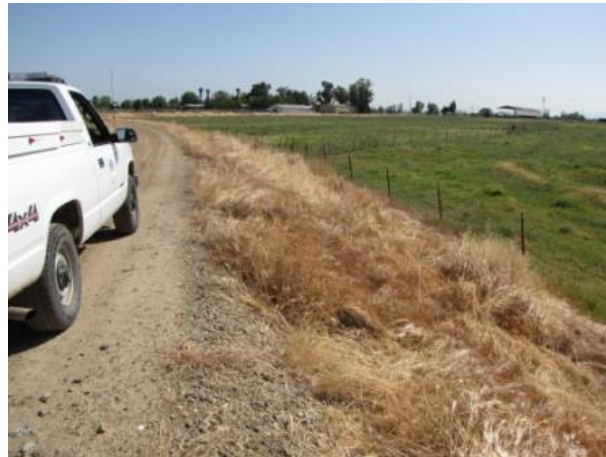
Levee Mile Report Line	80
Start Levee Mile	16.23
End Levee Mile	16.34
Location	Land Side
Category	Earthen Levee
Item	Vegetation
Remove/mow grass & vegetation along landward slope of levee & within 10' of the toe.

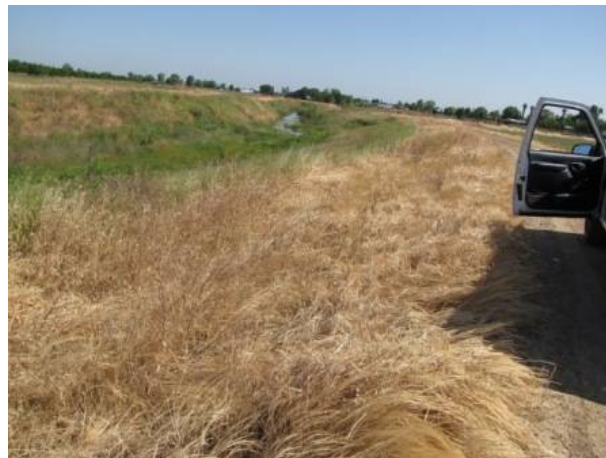
Levee Mile Report Line	81
Start Levee Mile	16.23
End Levee Mile	16.34
Location	Water Side
Category	Earthen Levee
Item	Vegetation
Remove/mow grass & vegetation along top 20' of waterward levee slope.

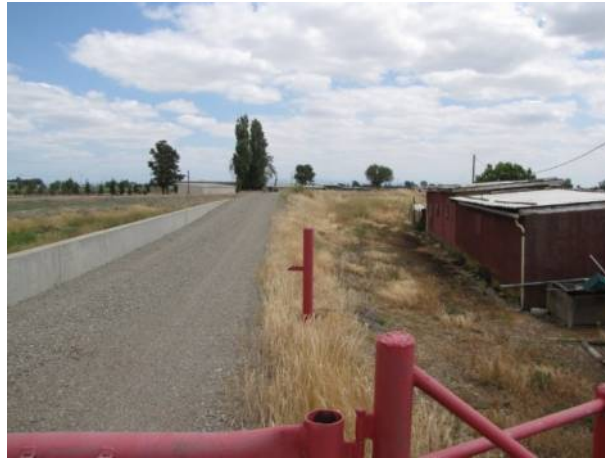
Levee Mile Report Line	4
Start Levee Mile	0.58
End Levee Mile	1.44
Location	Land Side
Category	Earthen Levee
Item	Vegetation
Remove/mow grass & vegetation along landward slope of levee & within 10' of the toe.

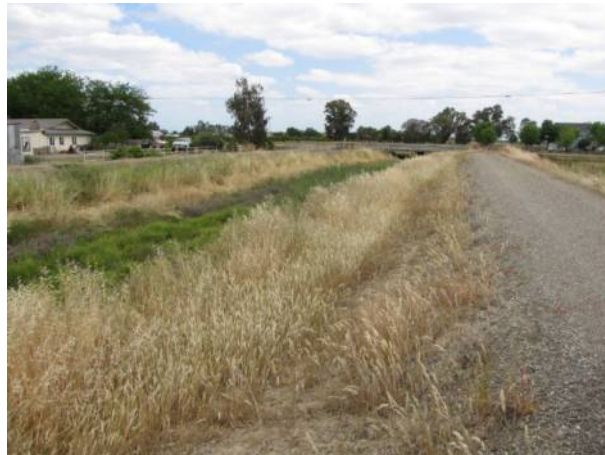
Levee Mile Report Line	5
Start Levee Mile	1.40
End Levee Mile	1.44
Location	Water Side
Category	Earthen Levee
Item	Vegetation
Remove/mow grass & vegetation along top 20' of waterward slope of levee.

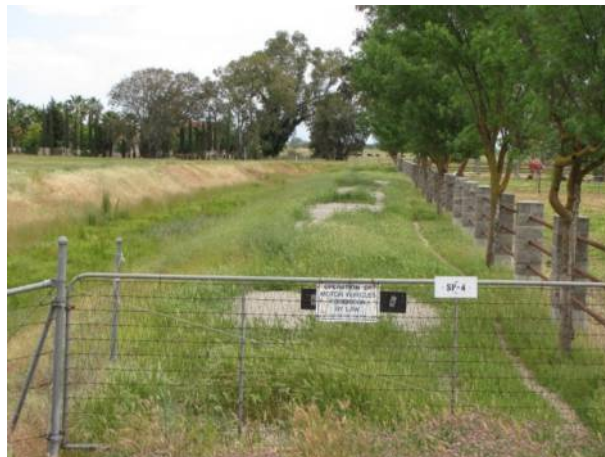
Levee Mile Report Line	6
Start Levee Mile	1.45
End Levee Mile	1.54
Location	Crown
Category	Earthen Levee
Item	Vegetation
Remove/mow grass & vegetation along crown of access road to allow for access.
